6.0 Recommended Projects

6.3 Project Sheets

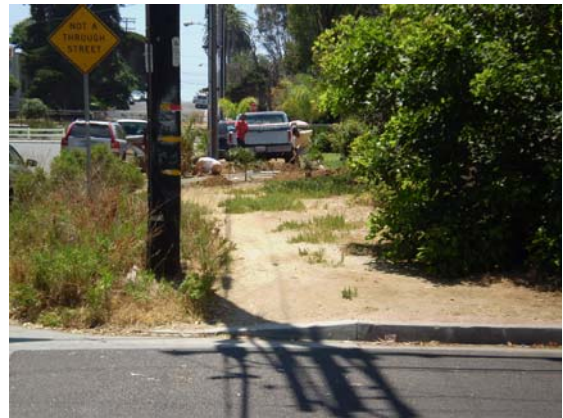
Sidewalk gaps are areas in Carlsbad where there are no sidewalks, or the sidewalk ends abruptly, resulting in a discontinuous pedestrian network. Areas without sidewalks may force pedestrians to walk along the edge of the roadway, or may cause pedestrians to cross at undesignated crossing locations. Providing a continuous pedestrian sidewalk along all of Carlsbad's roadways is recommended.

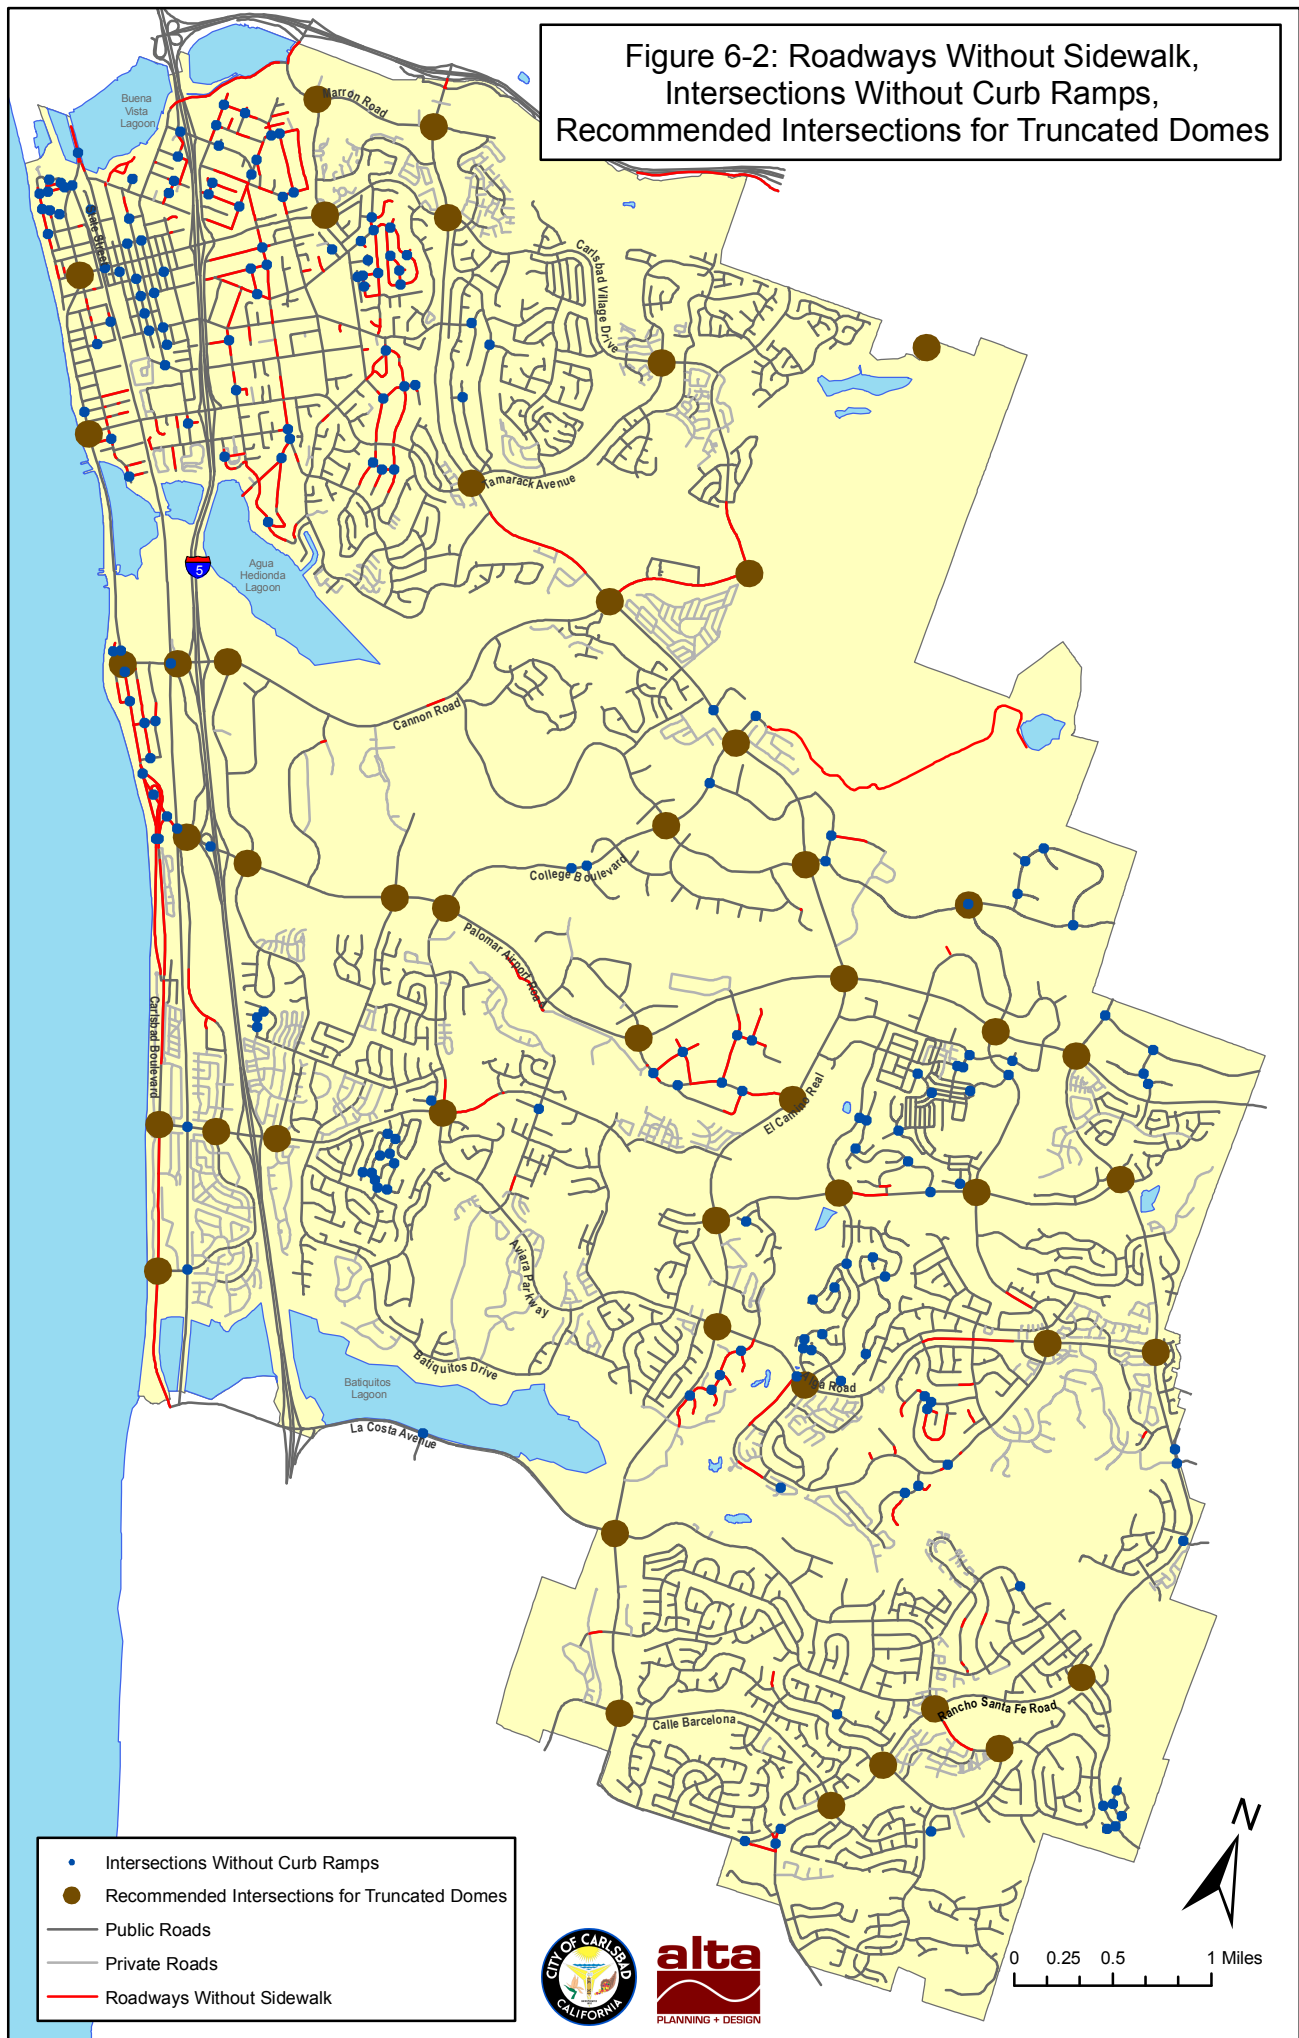
Figure 6-2: Roadways Without Sidewalk,
Intersections Without Curb Ramps,
Recommended Intersections for Truncated Domes

Figure 6-2 displays locations of roadway segments in Carlsbad with sidewalks missing on both sides of the roadway. Appendix B lists roadway segments in Carlsbad where sidewalks are missing along both sides of the street. The length of the missing sidewalk is shown along with an overall cost associated with completing all sidewalk infill projects across Carlsbad. As shown in Appendix B, there are approximately 275,620 feet—or 52.2 miles—of missing sidewalks in the City of Carlsbad. The majority of the missing sidewalks are in the Northwest quadrant, east of I-5 and north of Tamarack Avenue. Some of the roadways in the Northwest quadrant are classified as Alternative Design Streets, in which case, the City may forego sidewalk infill. In locations near schools, however, it is recommended that the City pursue sidewalk infill for improved safety of children walking to and from school.

Figure 6-2 displays locations of intersections in Carlsbad that have no curb ramps. There are a total of 733 intersections across the city that do not have curb ramps. This would translate into the installation of a total of 2,932 curb ramps (4 curb ramps at each intersection).

Appendix B displays the forty-six (46) intersection locations recommended for installation of truncated domes on the curb ramps. Figure 7-2 displays the recommended locations for installation of truncated domes on curb ramps.

RECOMMENDATION: Carlsbad should consider retrofitting truncated domes at all forty-six (46) arterial/arterial intersections where they are currently lacking, as shown in Figure 6-2.

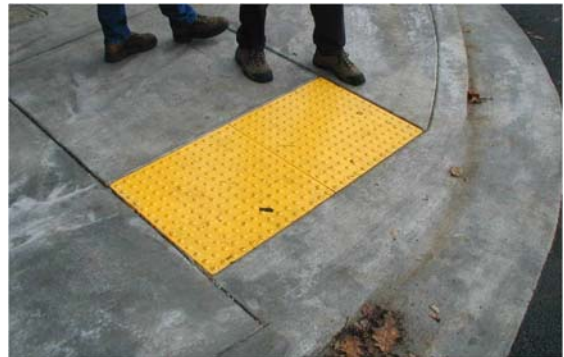
Truncated domes provide a cue to visually-impaired pedestrians that they are entering a street or intersection. Since 2002, ADA Guidelines (*Americans with Disabilities Act Accessibility Guidelines for Buildings and Facilities, September 2002*) have called for truncated domes on curb ramps. Most of Carlsbad's curb ramps lack truncated domes, because they were constructed prior to 2002. On streets that have been constructed since 2002, truncated domes should be installed.

Although it is not required for Carlsbad to install truncated domes at existing curb ramps that were built prior to 2002, the City may wish to install these devices at all high priority intersection locations. Truncated domes are a very visible improvement, and they are relatively inexpensive to install. The preferred option for retrofitting truncated domes requires saw-cutting out a 3x4 space in the ramp in order to embed the truncated dome panel flush with the surface. While more expensive

than simply epoxying the retrofit panel to an existing ramp, the saw-cutting ensures that the domes will not become detached and pose a tripping hazard.

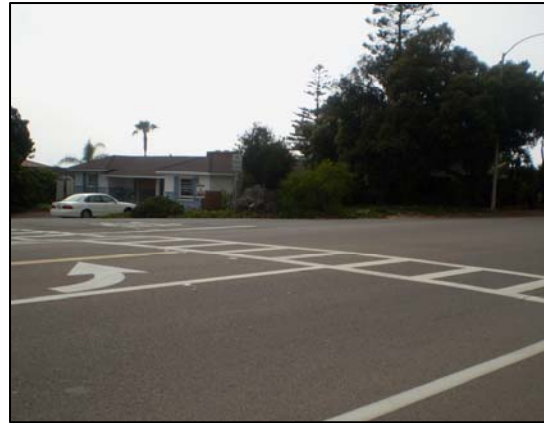
There are a variety of different striping styles for crosswalks. The City of Carlsbad utilizes two different marking styles for pedestrian crosswalks: the standard “transverse” style, consisting of two parallel lines; and the “ladder” style consisting of the two parallel lines with perpendicular ladder bars striped across the width of the crosswalk. Ladder style crosswalks should be used in locations where heightened pedestrian visibility is important, such as in school

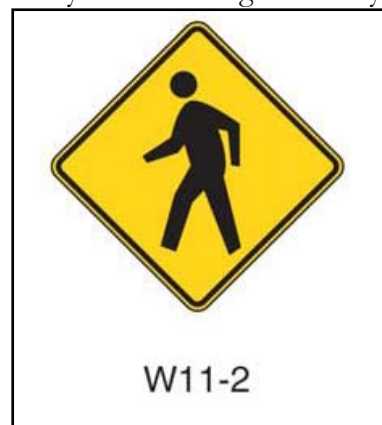
The City of Carlsbad's current pedestrian-related signage consists of a mix of current (California MUTCD) and older (California Traffic Manual) signs, in both standard yellow and high-visibility fluorescent yellow green. In accordance with MUTCD sign update schedule, the City of Carlsbad should develop a program to bring all signs up to current MUTCD standards. Of highest priority for pedestrians are the pedestrian advance warning (W11-2) and crossing signs (W11-2 with W16-7P down arrow).

The following considerations should be taken into account when installing signage:

1. Consistent use of standard yellow or fluorescent yellow green along a corridor or area. Avoid mixing signs of different color if possible.
2. To heighten visibility of specific pedestrian or school warning signs along major streets, consider using oversized (expressway size) sign plates.

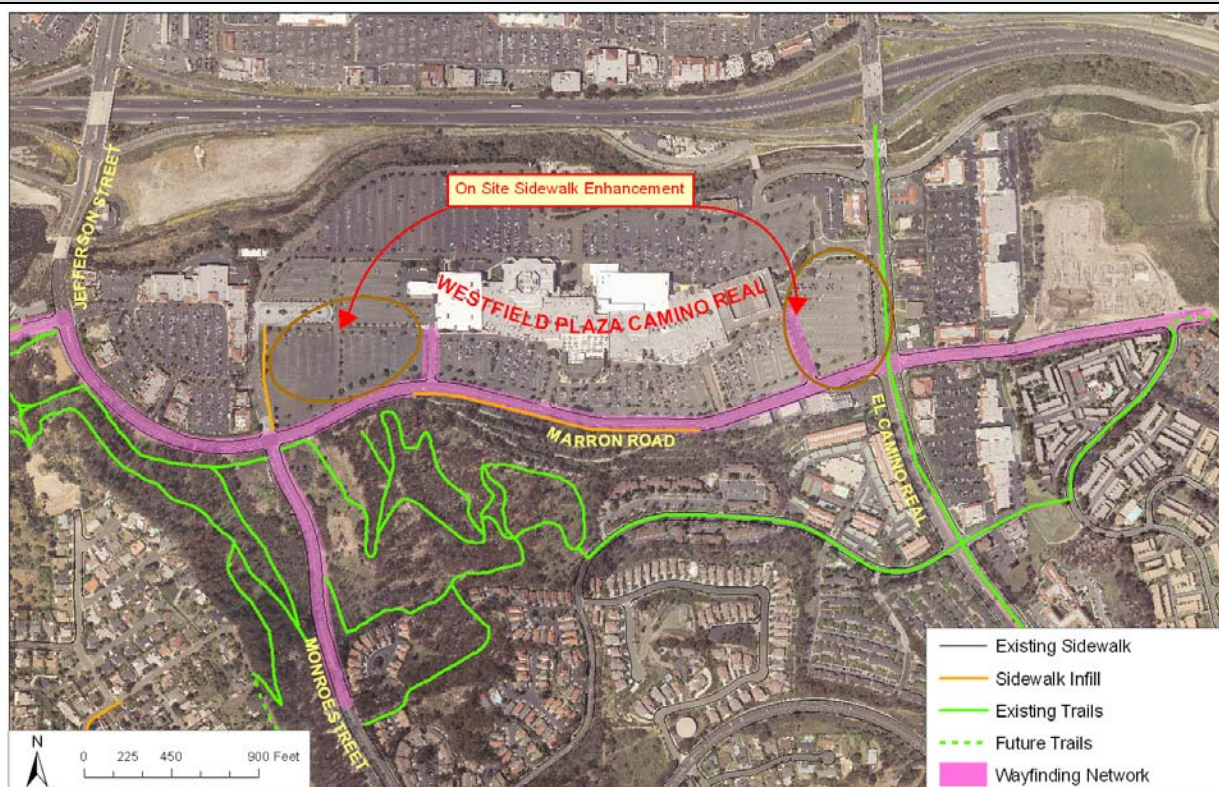
1. Plaza Camino Real Transit and Shopping Center

- Sidewalk infill along Marron Road and Westfield Plaza Camino Real entrance at Monroe Street \$136,706
- Wayfinding signage to connect major origins and destinations including trail access points, the shopping center, the Carlsbad Village, and coastal access points (8,430 feet of wayfinding network @ 1 sign/900 feet = \$3,000)

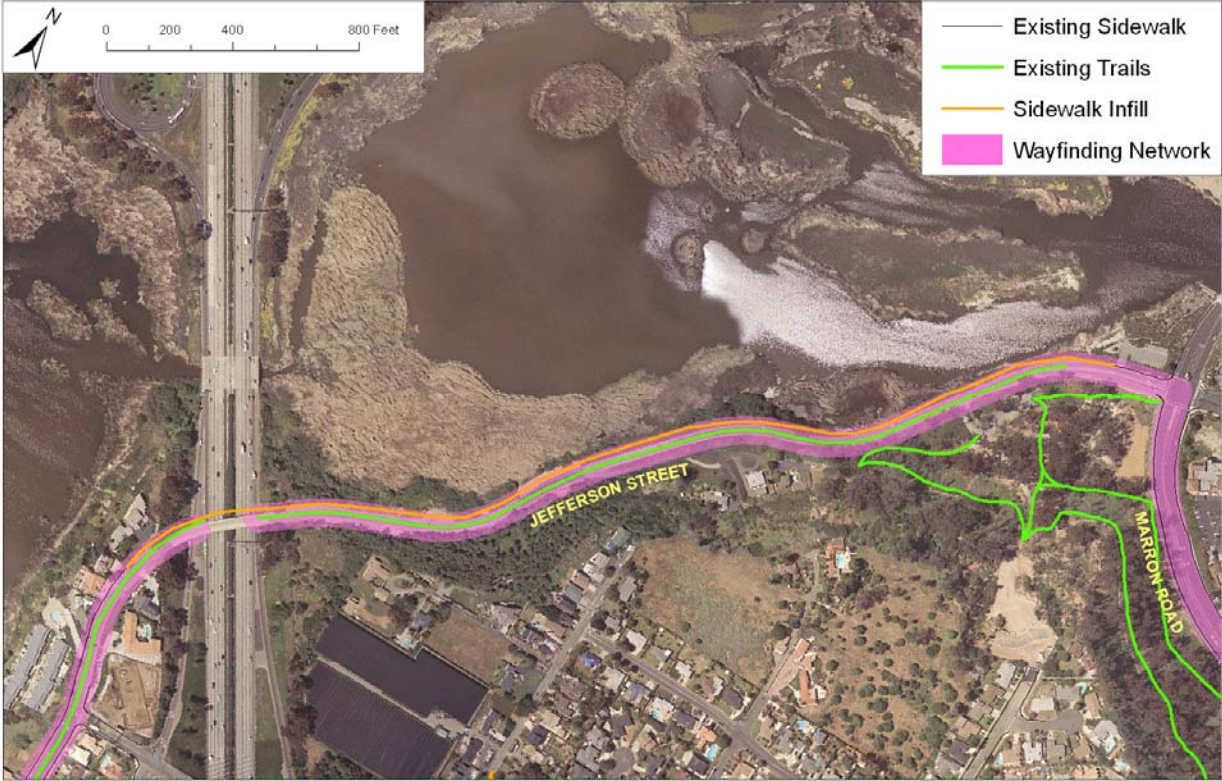
2. Jefferson Street Corridor

<ul style="list-style-type: none"> ▪ Sidewalk infill between Marron Road and Las Flores drive \$2,101,450 ▪ Network of signage promoting wayfinding to major origins and destinations including Plaza Camino Real shopping center, Carlsbad Village, coastal access points, and trail access points (6,470 feet of wayfinding network @ 1 sign/900 feet = \$2,400)

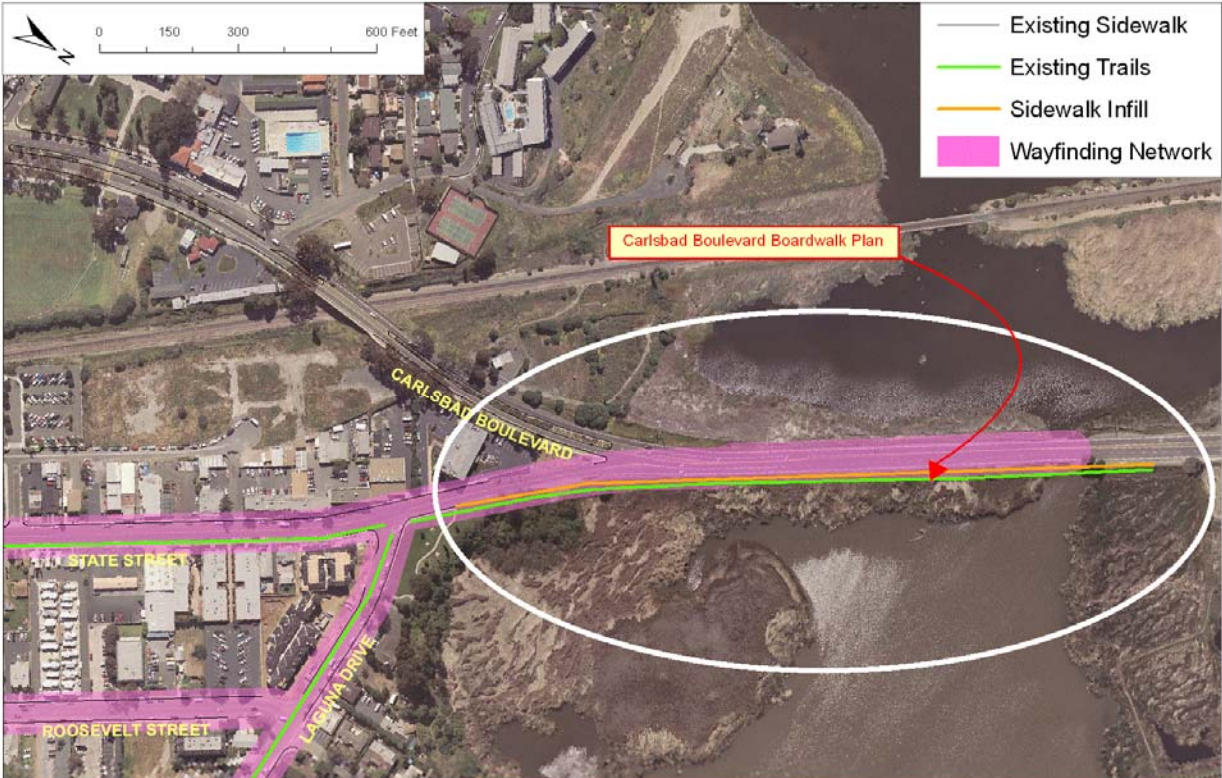
3. Carlsbad Boulevard (Buena Vista Lagoon Crossing)

<ul style="list-style-type: none"> ▪ Install sidewalk facilities from Carlsbad's northern boundary and the City of Oceanside, south to Laguna Drive \$67,635 ▪ Wayfinding network (4,620 feet of wayfinding network @ 1 sign / 900 feet = \$1,800)

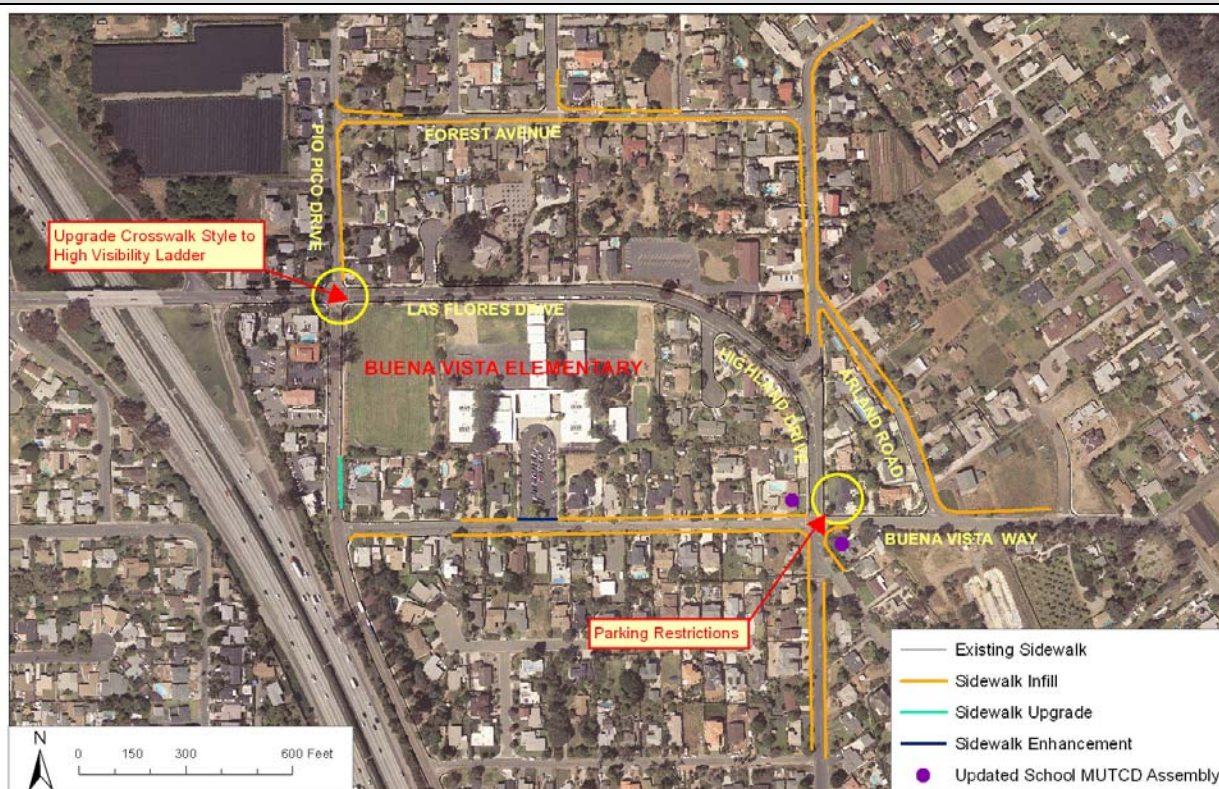
4. Buena Vista Elementary

- Install missing sidewalk facilities along Buena Vista Way, Highland Drive, Pio Pico Way, Arland Road and Forest Avenue \$471,583
- Enhanced sidewalks at drop-off/pick-up area in front of school \$9,000
- Parking restrictions on the northeast corner of Highland Drive and Buena Vista Way \$20
- High visibility restriping of the crosswalk along the east leg of Pio Pico Drive/Las Flores Drive intersection \$1,200
- Updated school warning traffic assembly at the northwest and southeast corners of the Highland Drive/Buena Vista Way intersection \$600

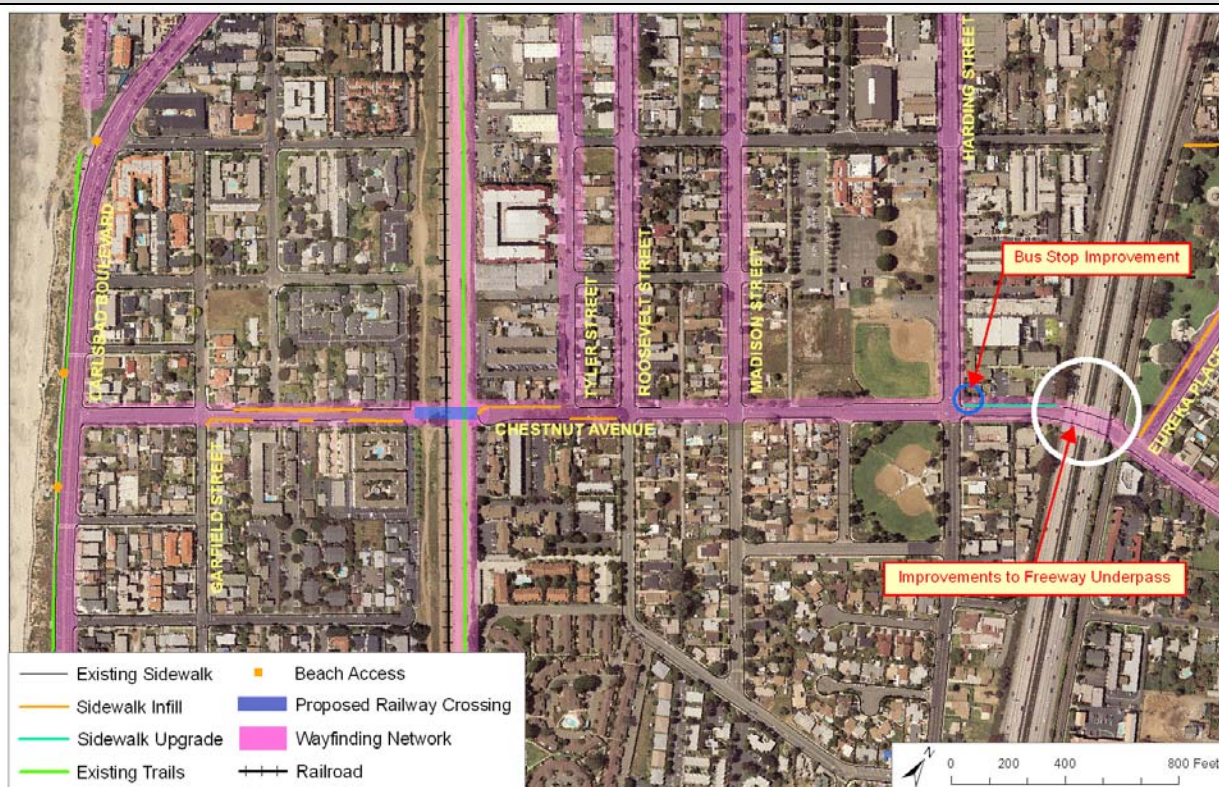
6. Chestnut Avenue Corridor

- Sidewalk infill and upgrade along Chestnut Avenue and Eureka Place \$89,373
- Add bus stop improvements (bench, shelter, and signage) at Chestnut Avenue and Harding Street intersection \$40,000
- Network of signage promoting wayfinding to major origins and destinations including points of coastal access, the Carlsbad Village, parks, shopping and dining areas, and trail access points (6,097 feet of wayfinding network @ 1 sign/900 feet = \$2,100)
- Proposed Railway Crossing (costing not provided)

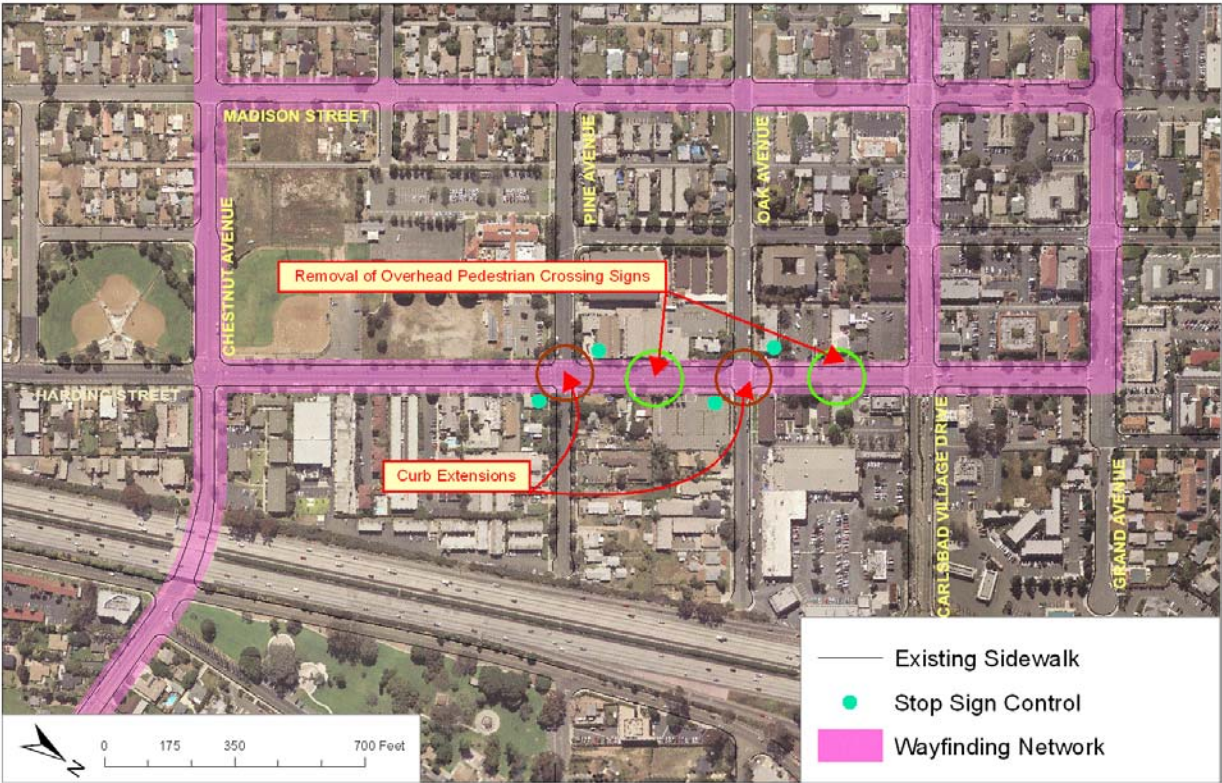
7. Harding Street Corridor

<ul style="list-style-type: none"> ▪ Install north/south stop sign control along Harding Street at the Harding Street/Pine Avenue and Harding Street/Oak Avenue intersections \$1,200 ▪ Construct curb extensions at Harding Street/Pine Avenue and Harding Street/Oak Avenue intersections \$372,703 ▪ Remove two overhead pedestrian warning signals along Harding Street between Carlsbad Village Drive and Pine Avenue \$240

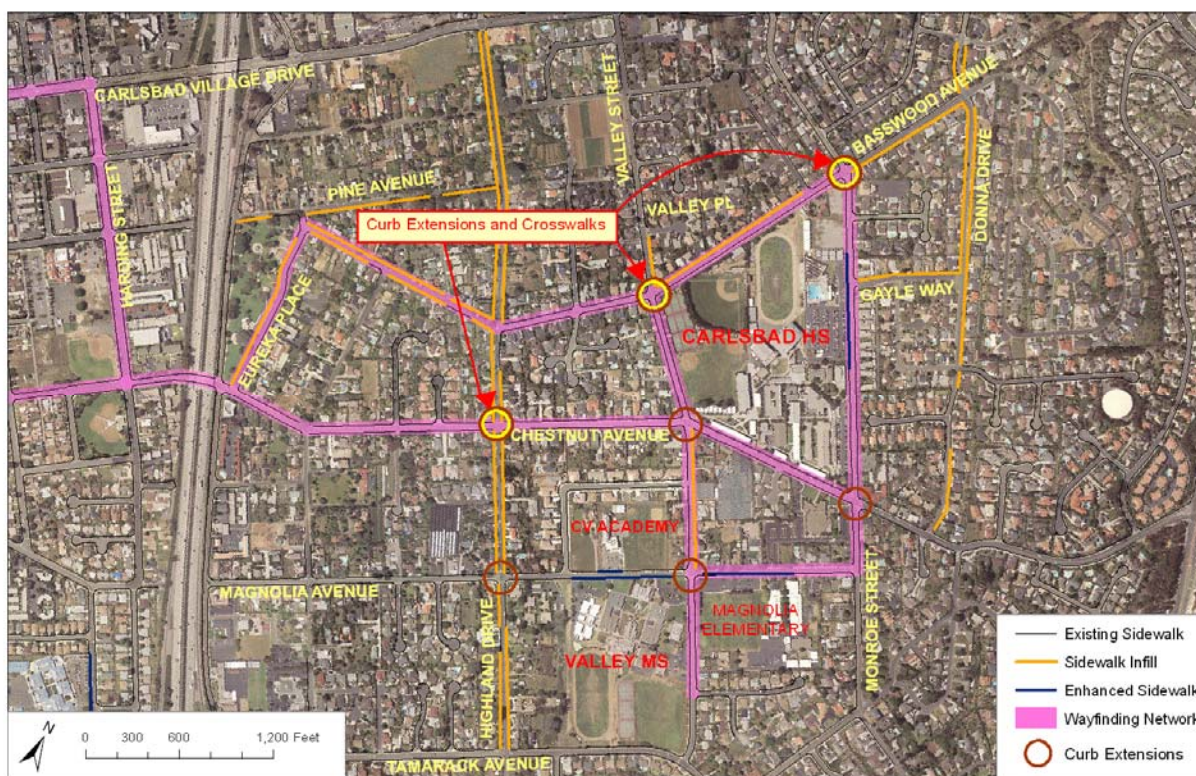
8. Carlsbad High and Surrounding Schools

- Missing sidewalk installation \$1,451,017
- Enhanced 10' sidewalks near school drop-off/pick-up \$195,660
- Curb extension installations (28 curb extensions) \$696,083
- Crosswalks (12 high visibility) \$14,400
- Wayfinding network (15,371 feet of wayfinding network @ 1 sign/900 feet = \$5,400)

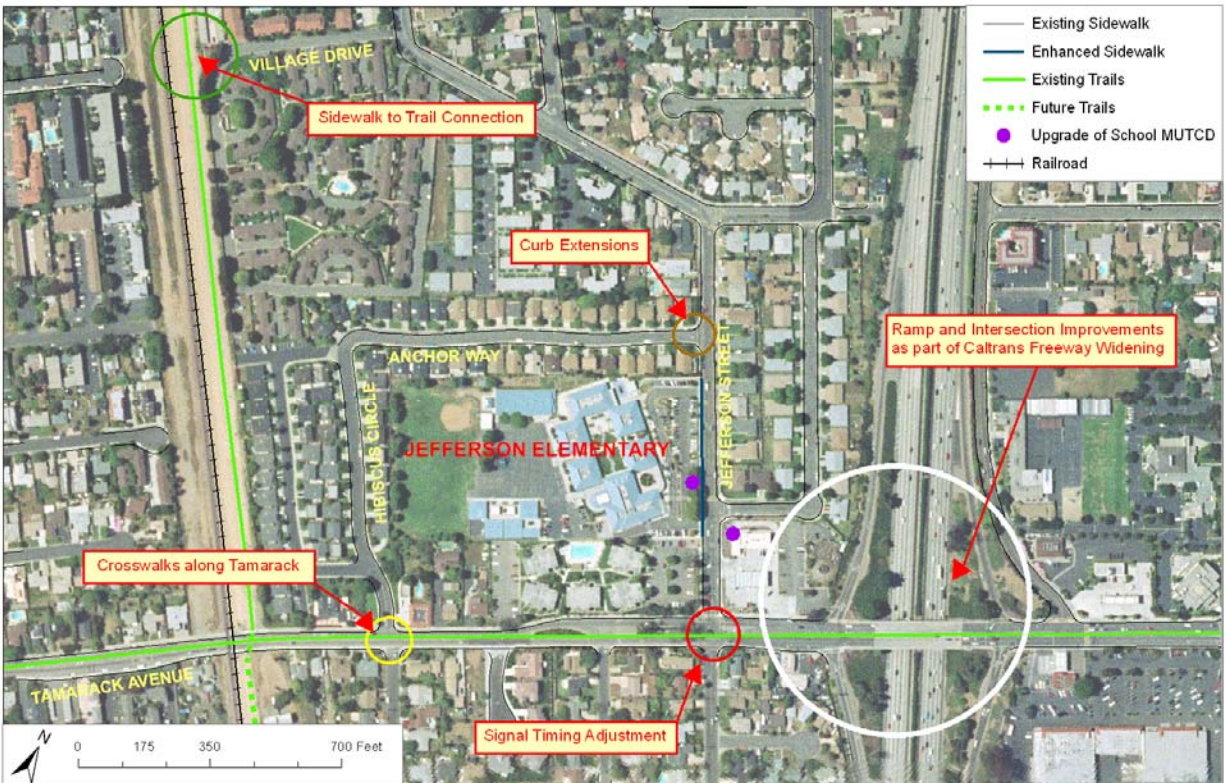
9. Jefferson Elementary

<ul style="list-style-type: none"> ▪ Install a crosswalk along the north leg of the Tamarack Avenue/Hibiscus Circle intersection \$1,200 ▪ Enhanced 10' sidewalks at pick-up/drop-off areas in front of school \$37,080 ▪ Adjust the signal timing at the Jefferson Street/Tamarack Avenue intersection ▪ Provide a connection to the Coastal Rail Trail from Village Drive \$10,000 ▪ Upgrade school sign assembly at the northwest and southeast corners of the Jefferson Street and Carol Place intersection \$600

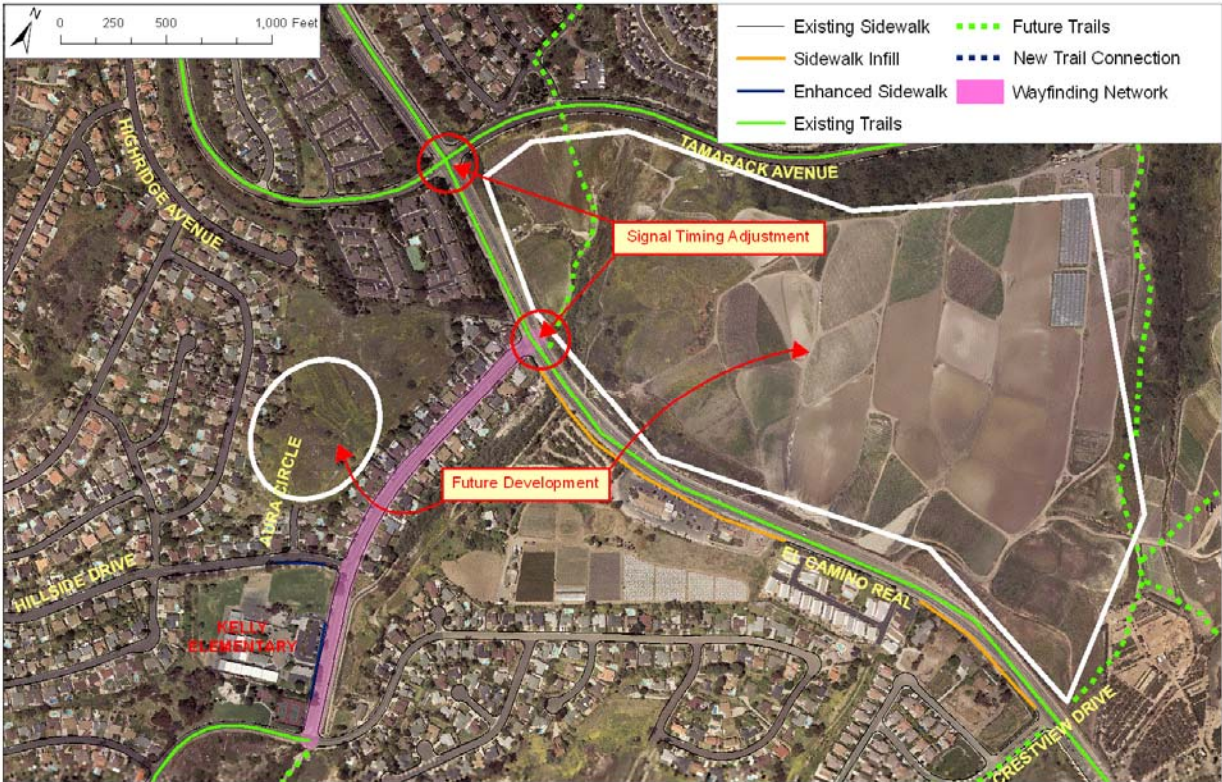
11. Kelly Elementary School

<ul style="list-style-type: none"> ▪ Signal timing adjustments at two intersections ▪ Enhanced 10' sidewalks at school drop-off/pick-up area \$81,000 ▪ Install Class I path connecting High Ridge Avenue and Aura Circle \$143,400 ▪ Install missing sidewalk facilities along El Camino Real between Tamarack Avenue and Crestview Drive \$134,744 ▪ Wayfinding signage to connect major origins and destinations including the school, trail access points, and parks (2,248 feet of wayfinding network @ 1 sign/900 feet = \$900)

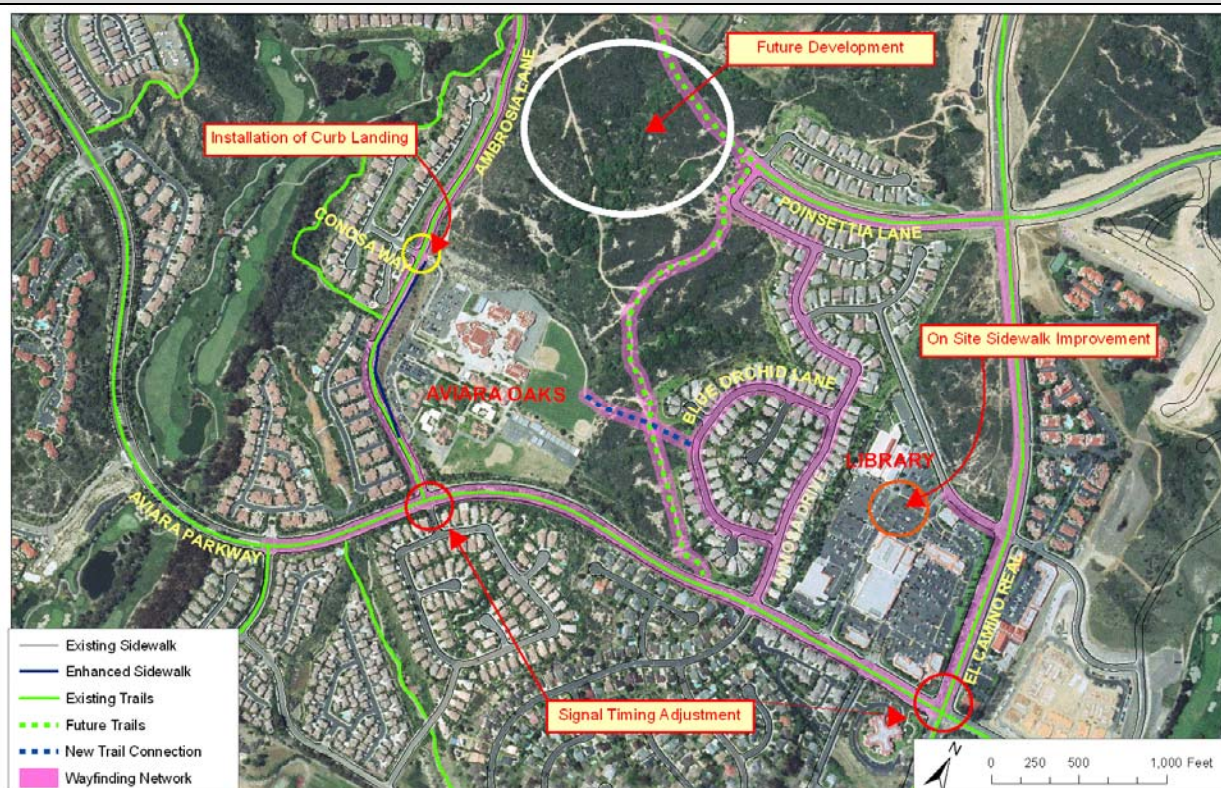
14. Aviara Oaks Elementary and Middle School

- Install curb landing at the NE corner of the Ambrosia Lane and Conosa Way intersection \$100,000
- Signal timing adjustment at two intersections
- Enhanced 10' sidewalks at school drop-off/pick-up \$103,410
- Install Class I path facility connecting the library to Aviara Oaks schools via the northeastern baseball path. \$190,362
- Wayfinding signage to connect major origins and destinations including the school, trail access points, public library, and parks. (22,618 feet of wayfinding network @1 sign/900 feet = \$7,800)

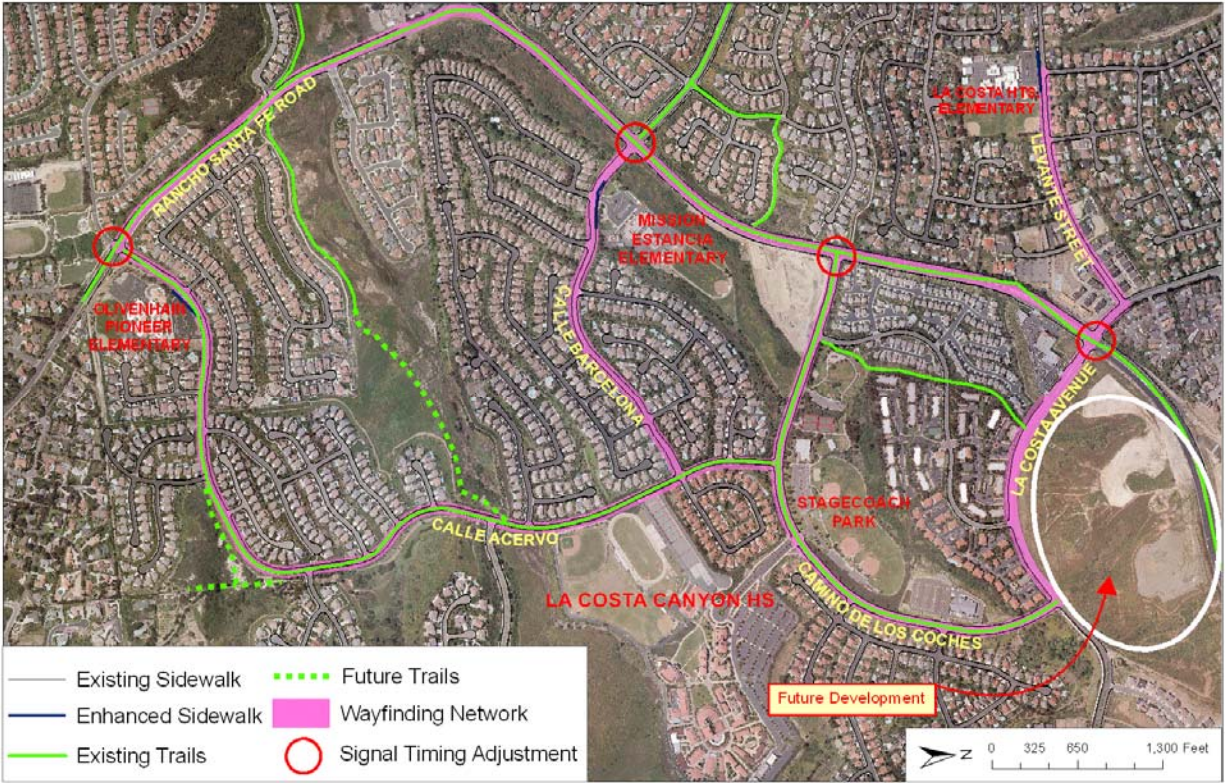
15. La Costa Canyon High and Surrounding Schools

<p> Existing Sidewalk Future Trails Enhanced Sidewalk Wayfinding Network Existing Trails Signal Timing Adjustment </p>
<ul style="list-style-type: none"> ▪ Enhanced 10' sidewalks at school pick-up/drop-off \$95,760 ▪ Signal timing adjustment at four intersections ▪ Wayfinding signage to connect major origins and destinations including schools, trail access points, and parks (27,995 feet of wayfinding network @1 sign/900 feet = \$9,600)
